INDUSTRY WASTE STUDY. THE HAWAII SUGAR INDUSTRY WASTE STUDY

Environmental Protection Agency
San Francisco, California

June 1971

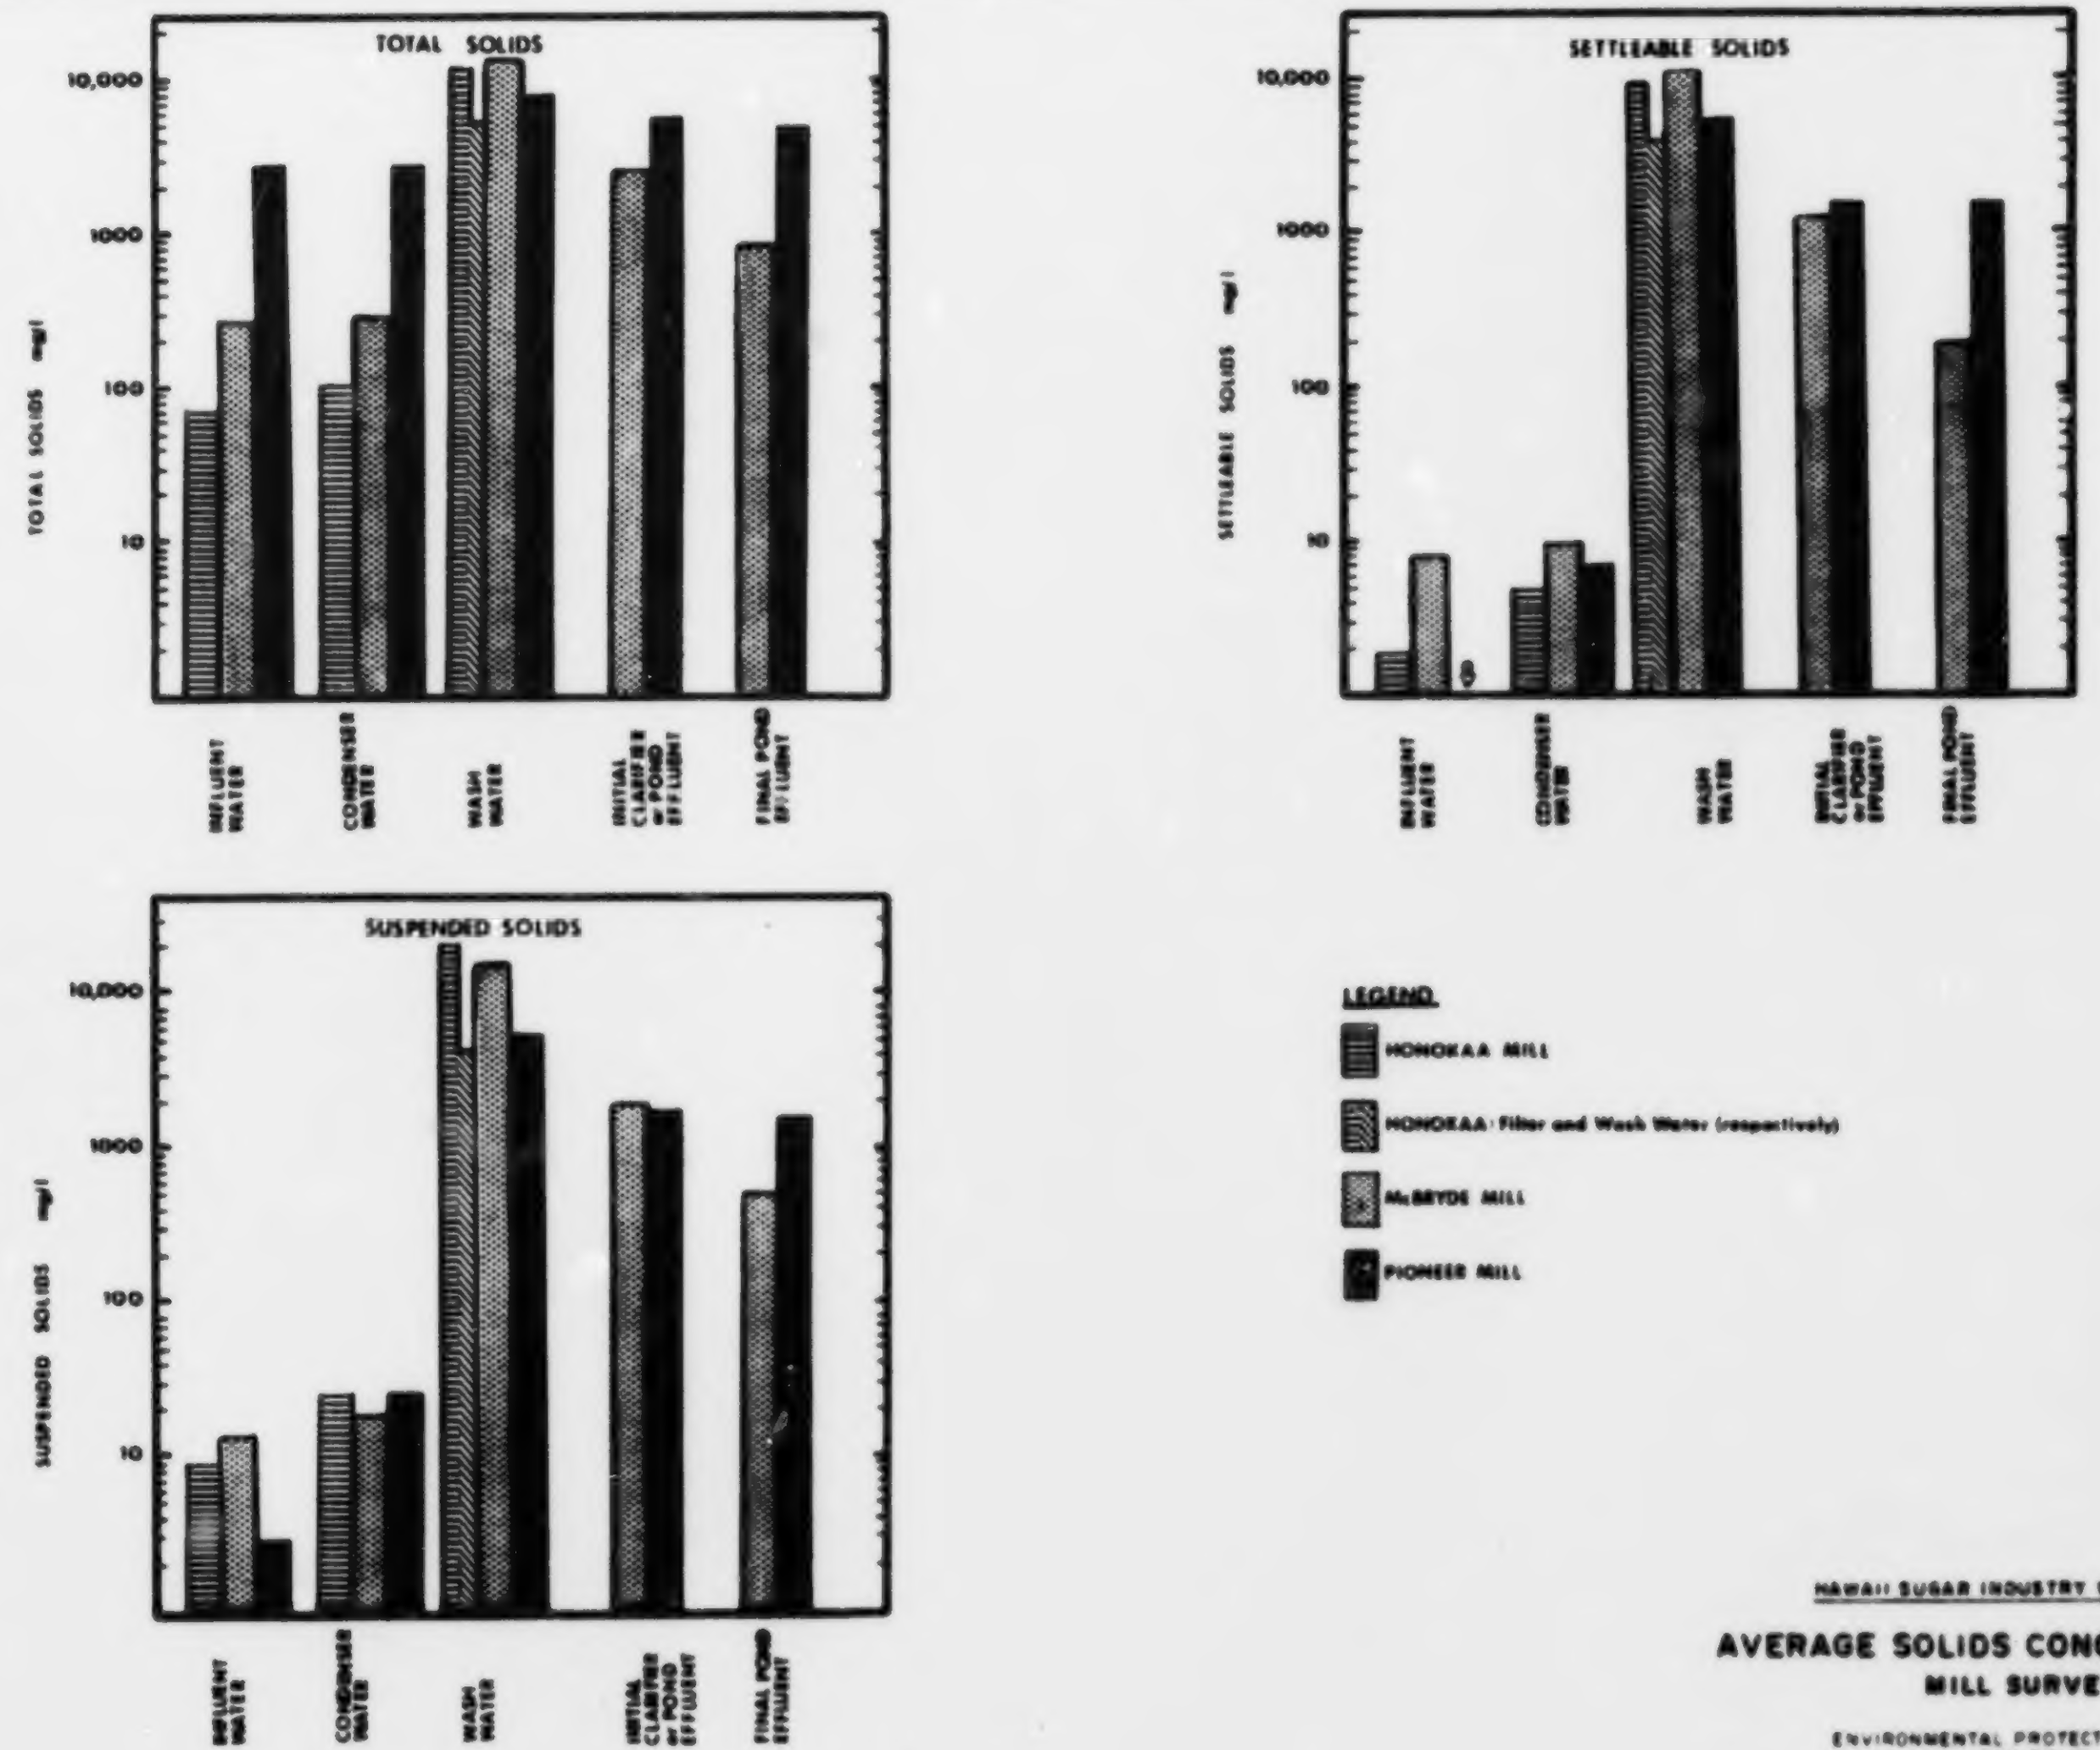
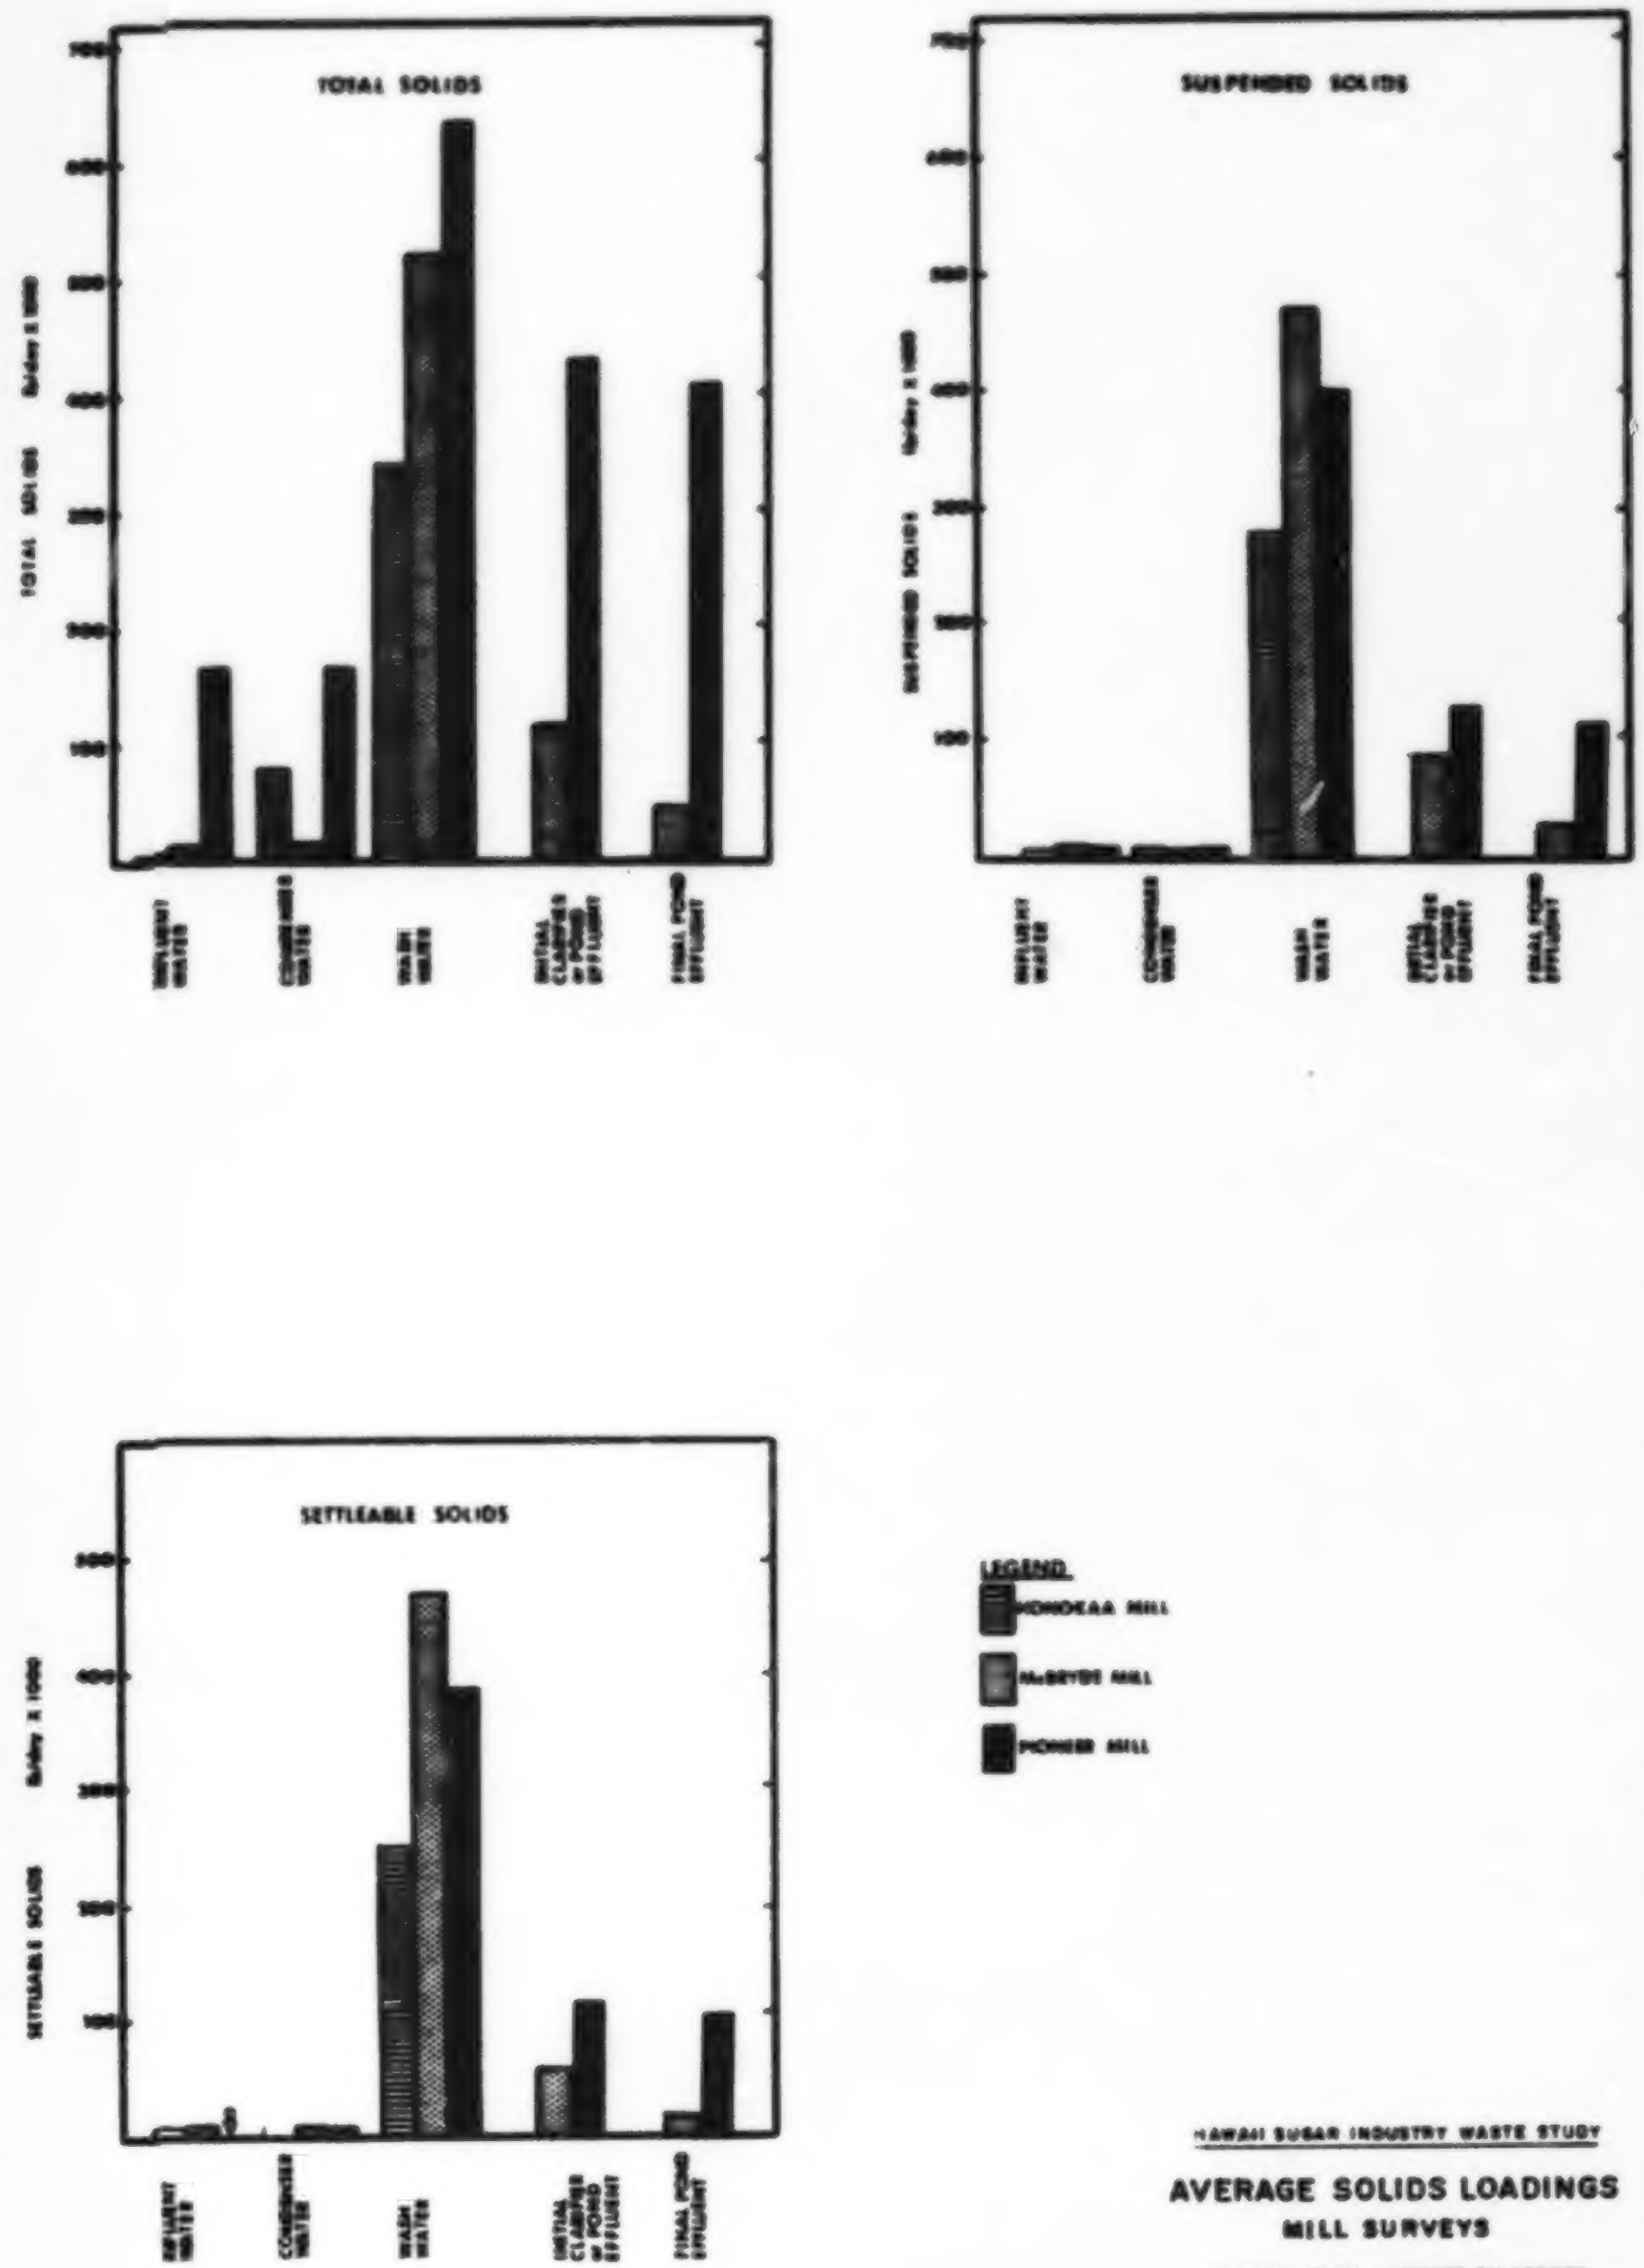
The most striking and significant relationship shown in Figures 8 and 9 is the high percentage of settleable solids contained in the suspended material. In all cases, more than 90 per cent of the suspended solids were of a settleable nature. This was further verified by the high removal percentages.

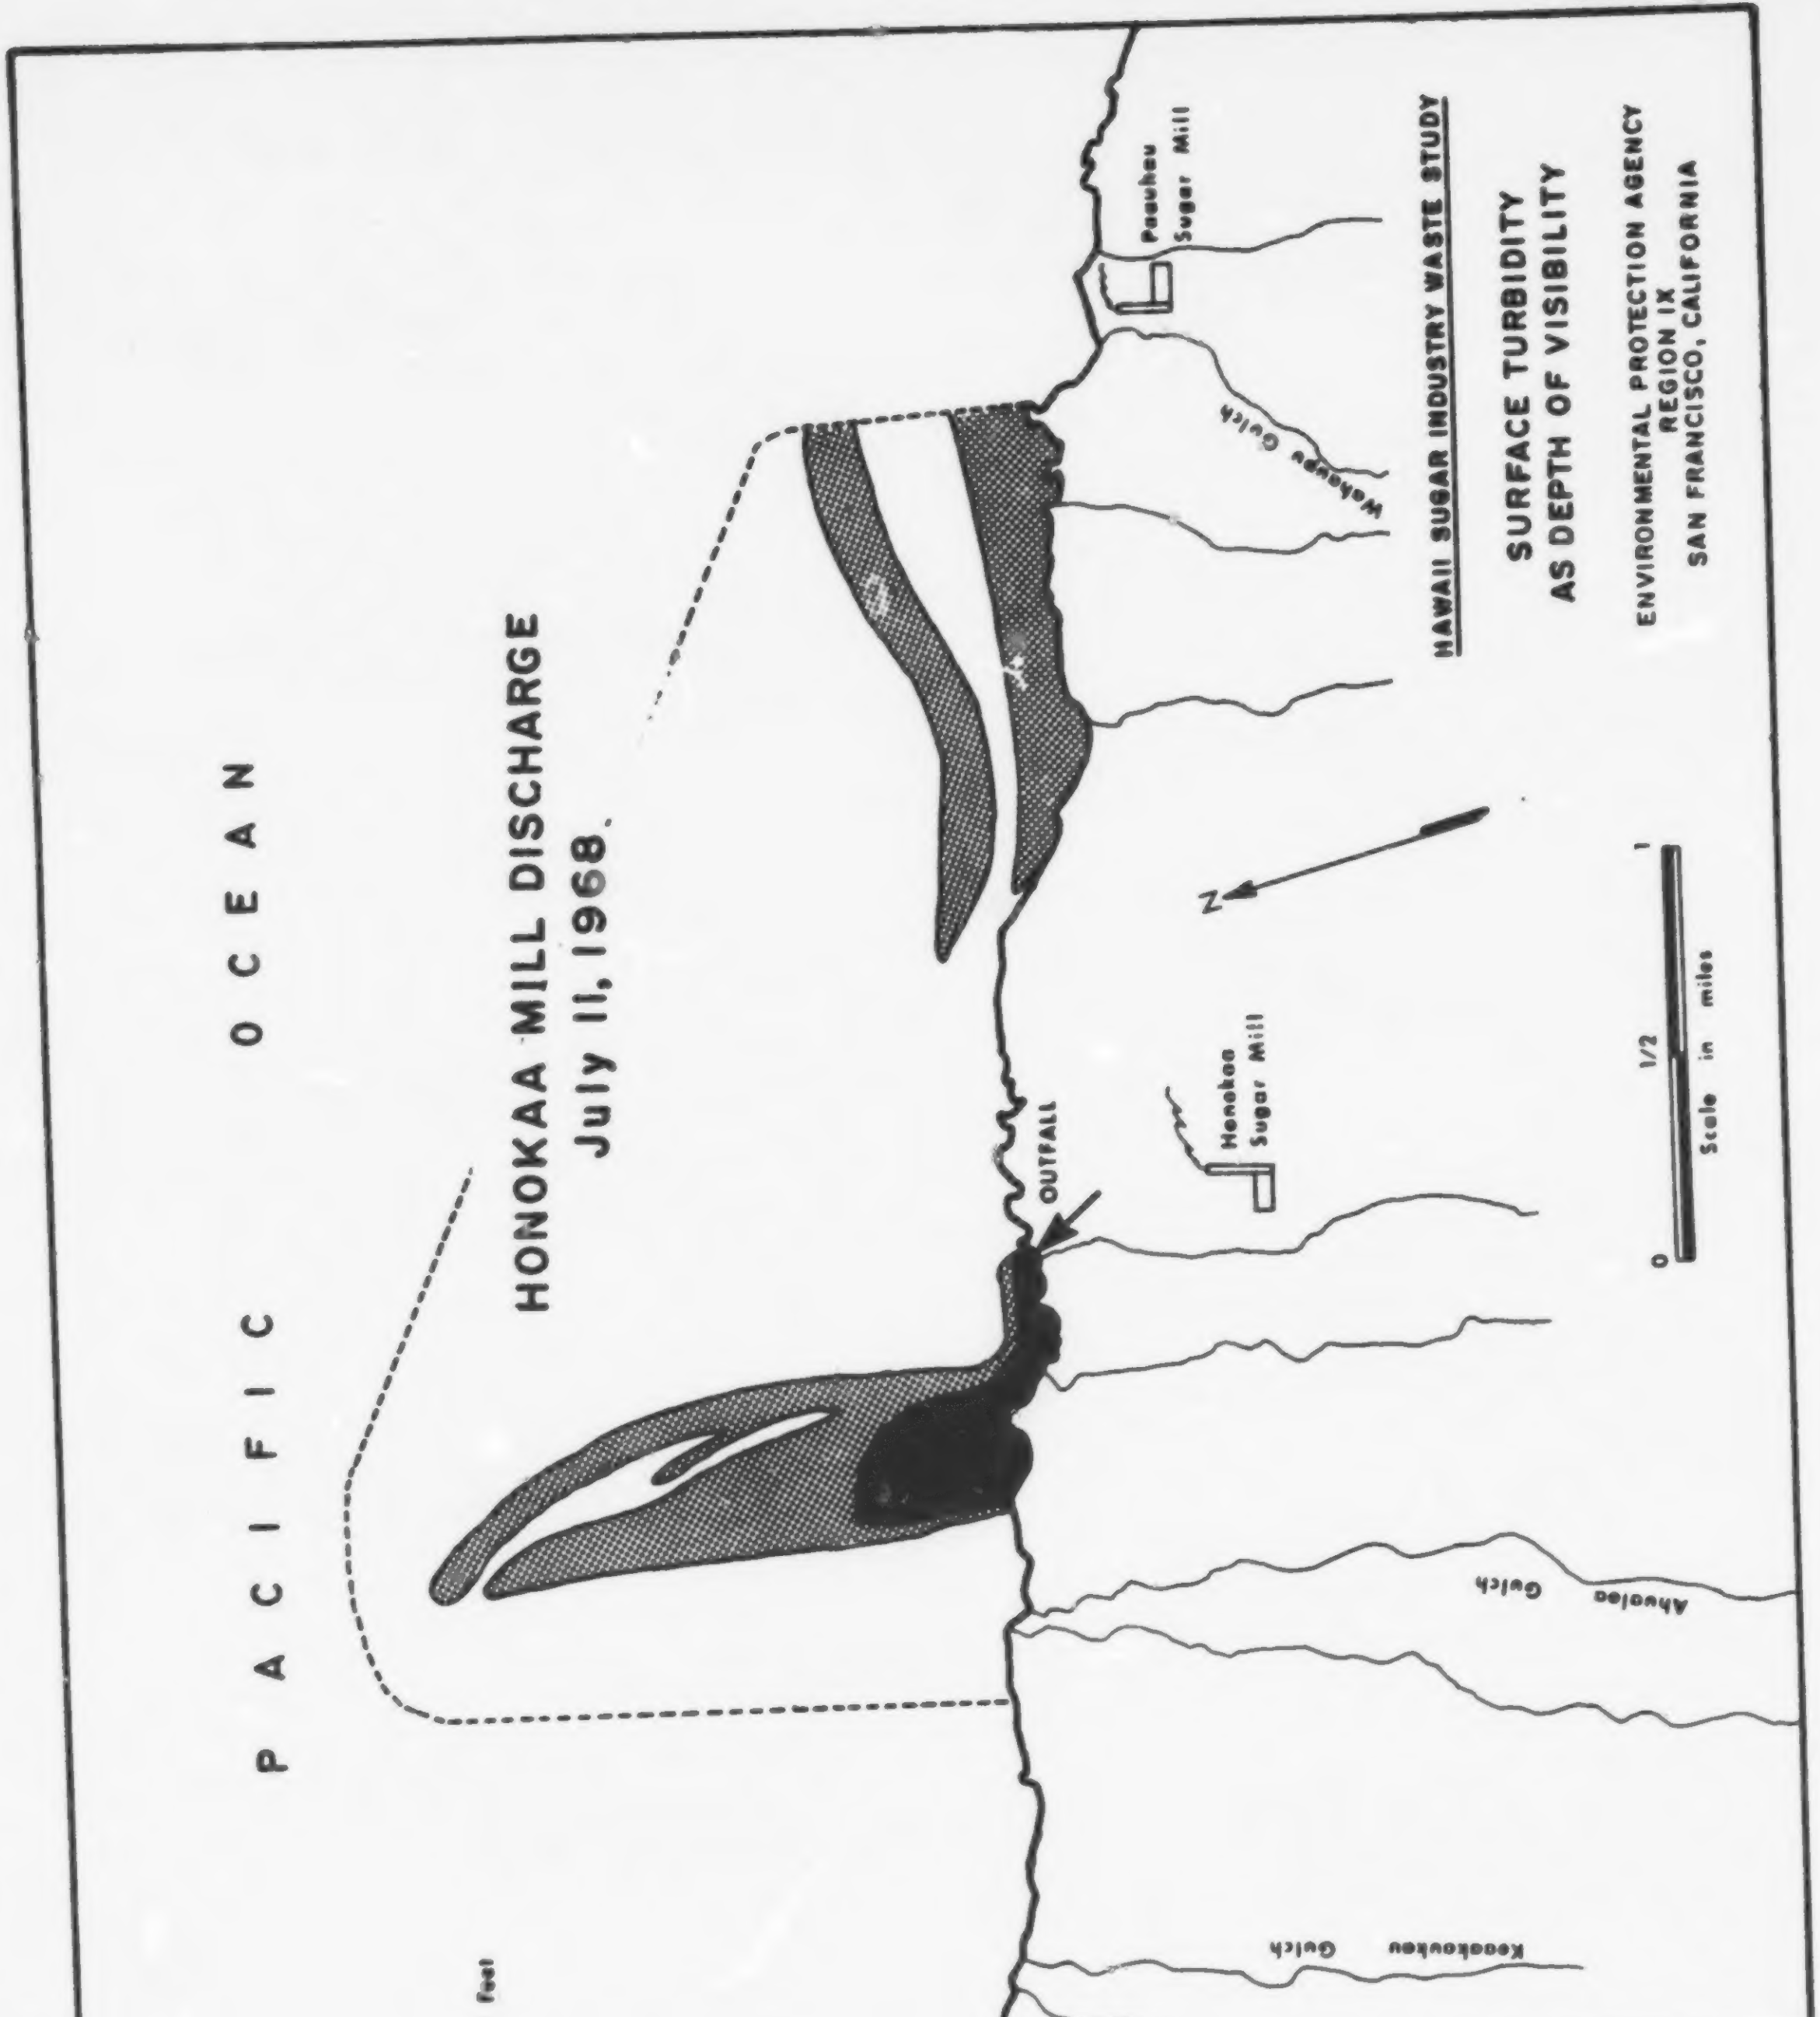
FIGURE 14

Honokaa Mill: Figure 14 illustrates the Honokaa plume on July 11, 1968. On this day, the plume was headed out to sea. The turbidity was swept westward for about a quarter mile along the small inlet, possibly because of local circulation in the bay. From there it was swept out to sea; inroads of clearer water entered the plume as its distance from shore increased. A rising tide was in progress throughout the measurements and tended to push the plume

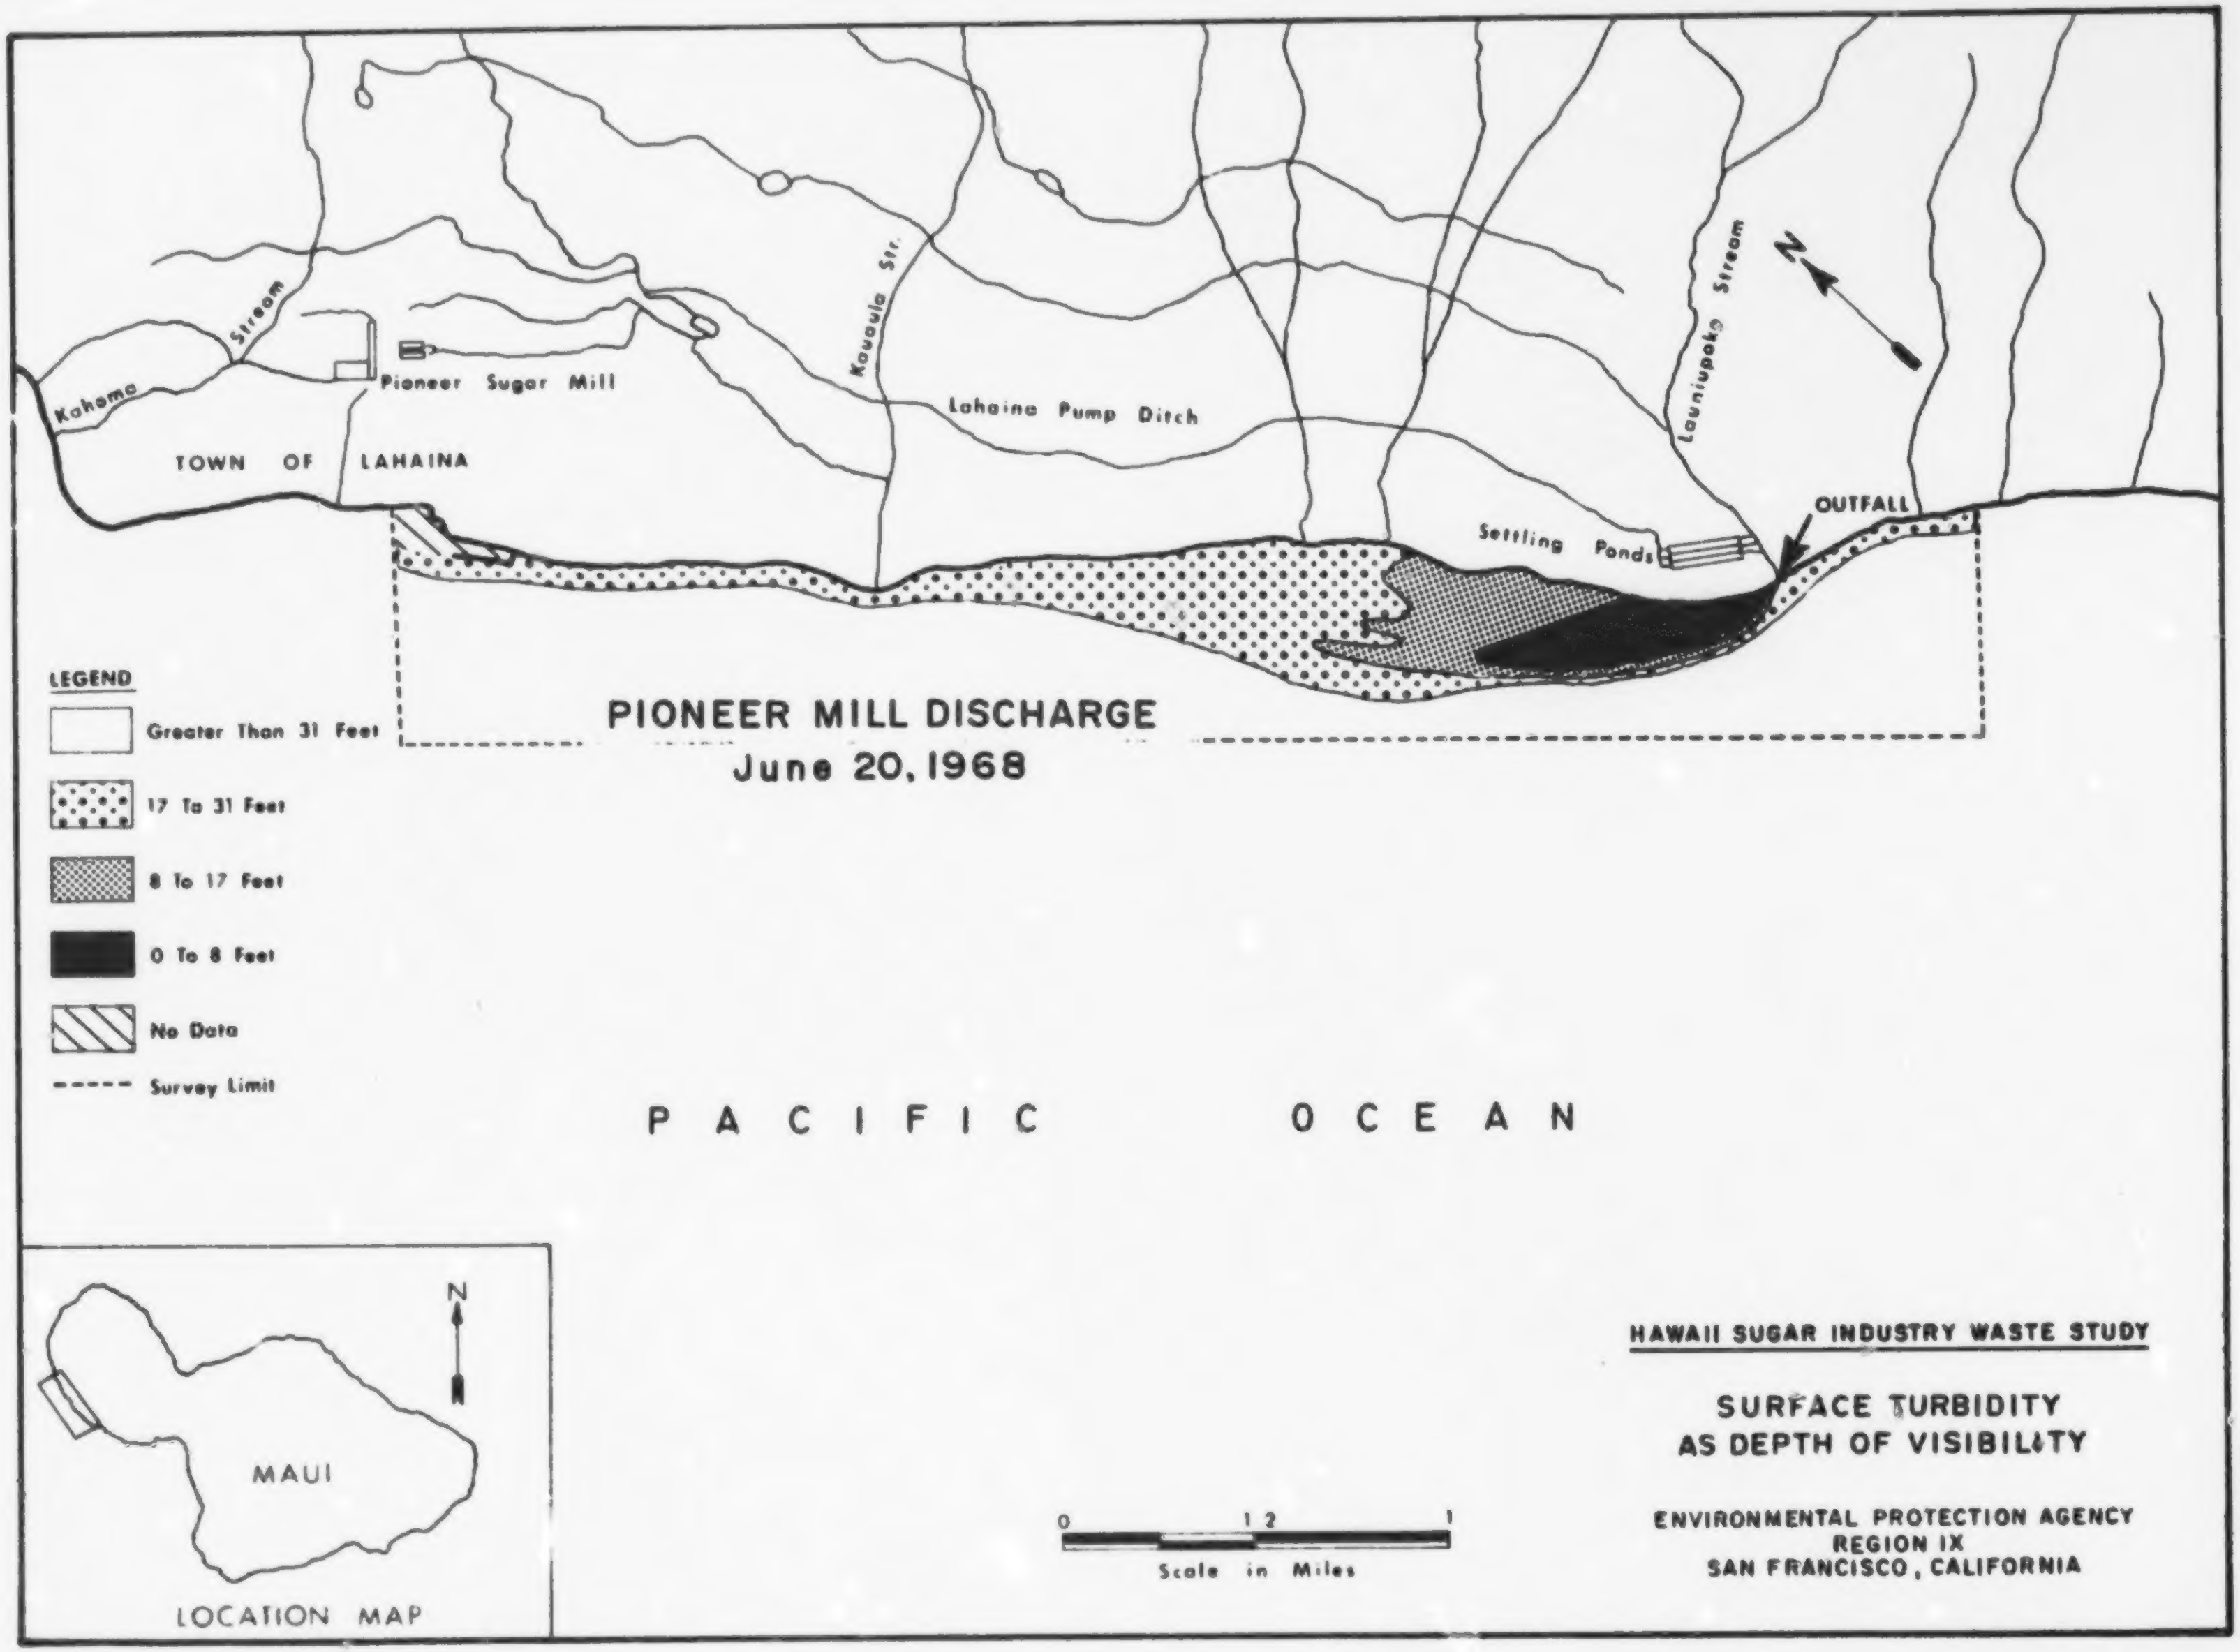
FIGURE 15

PIONEER MILL DISCHARGE
June 20, 1968

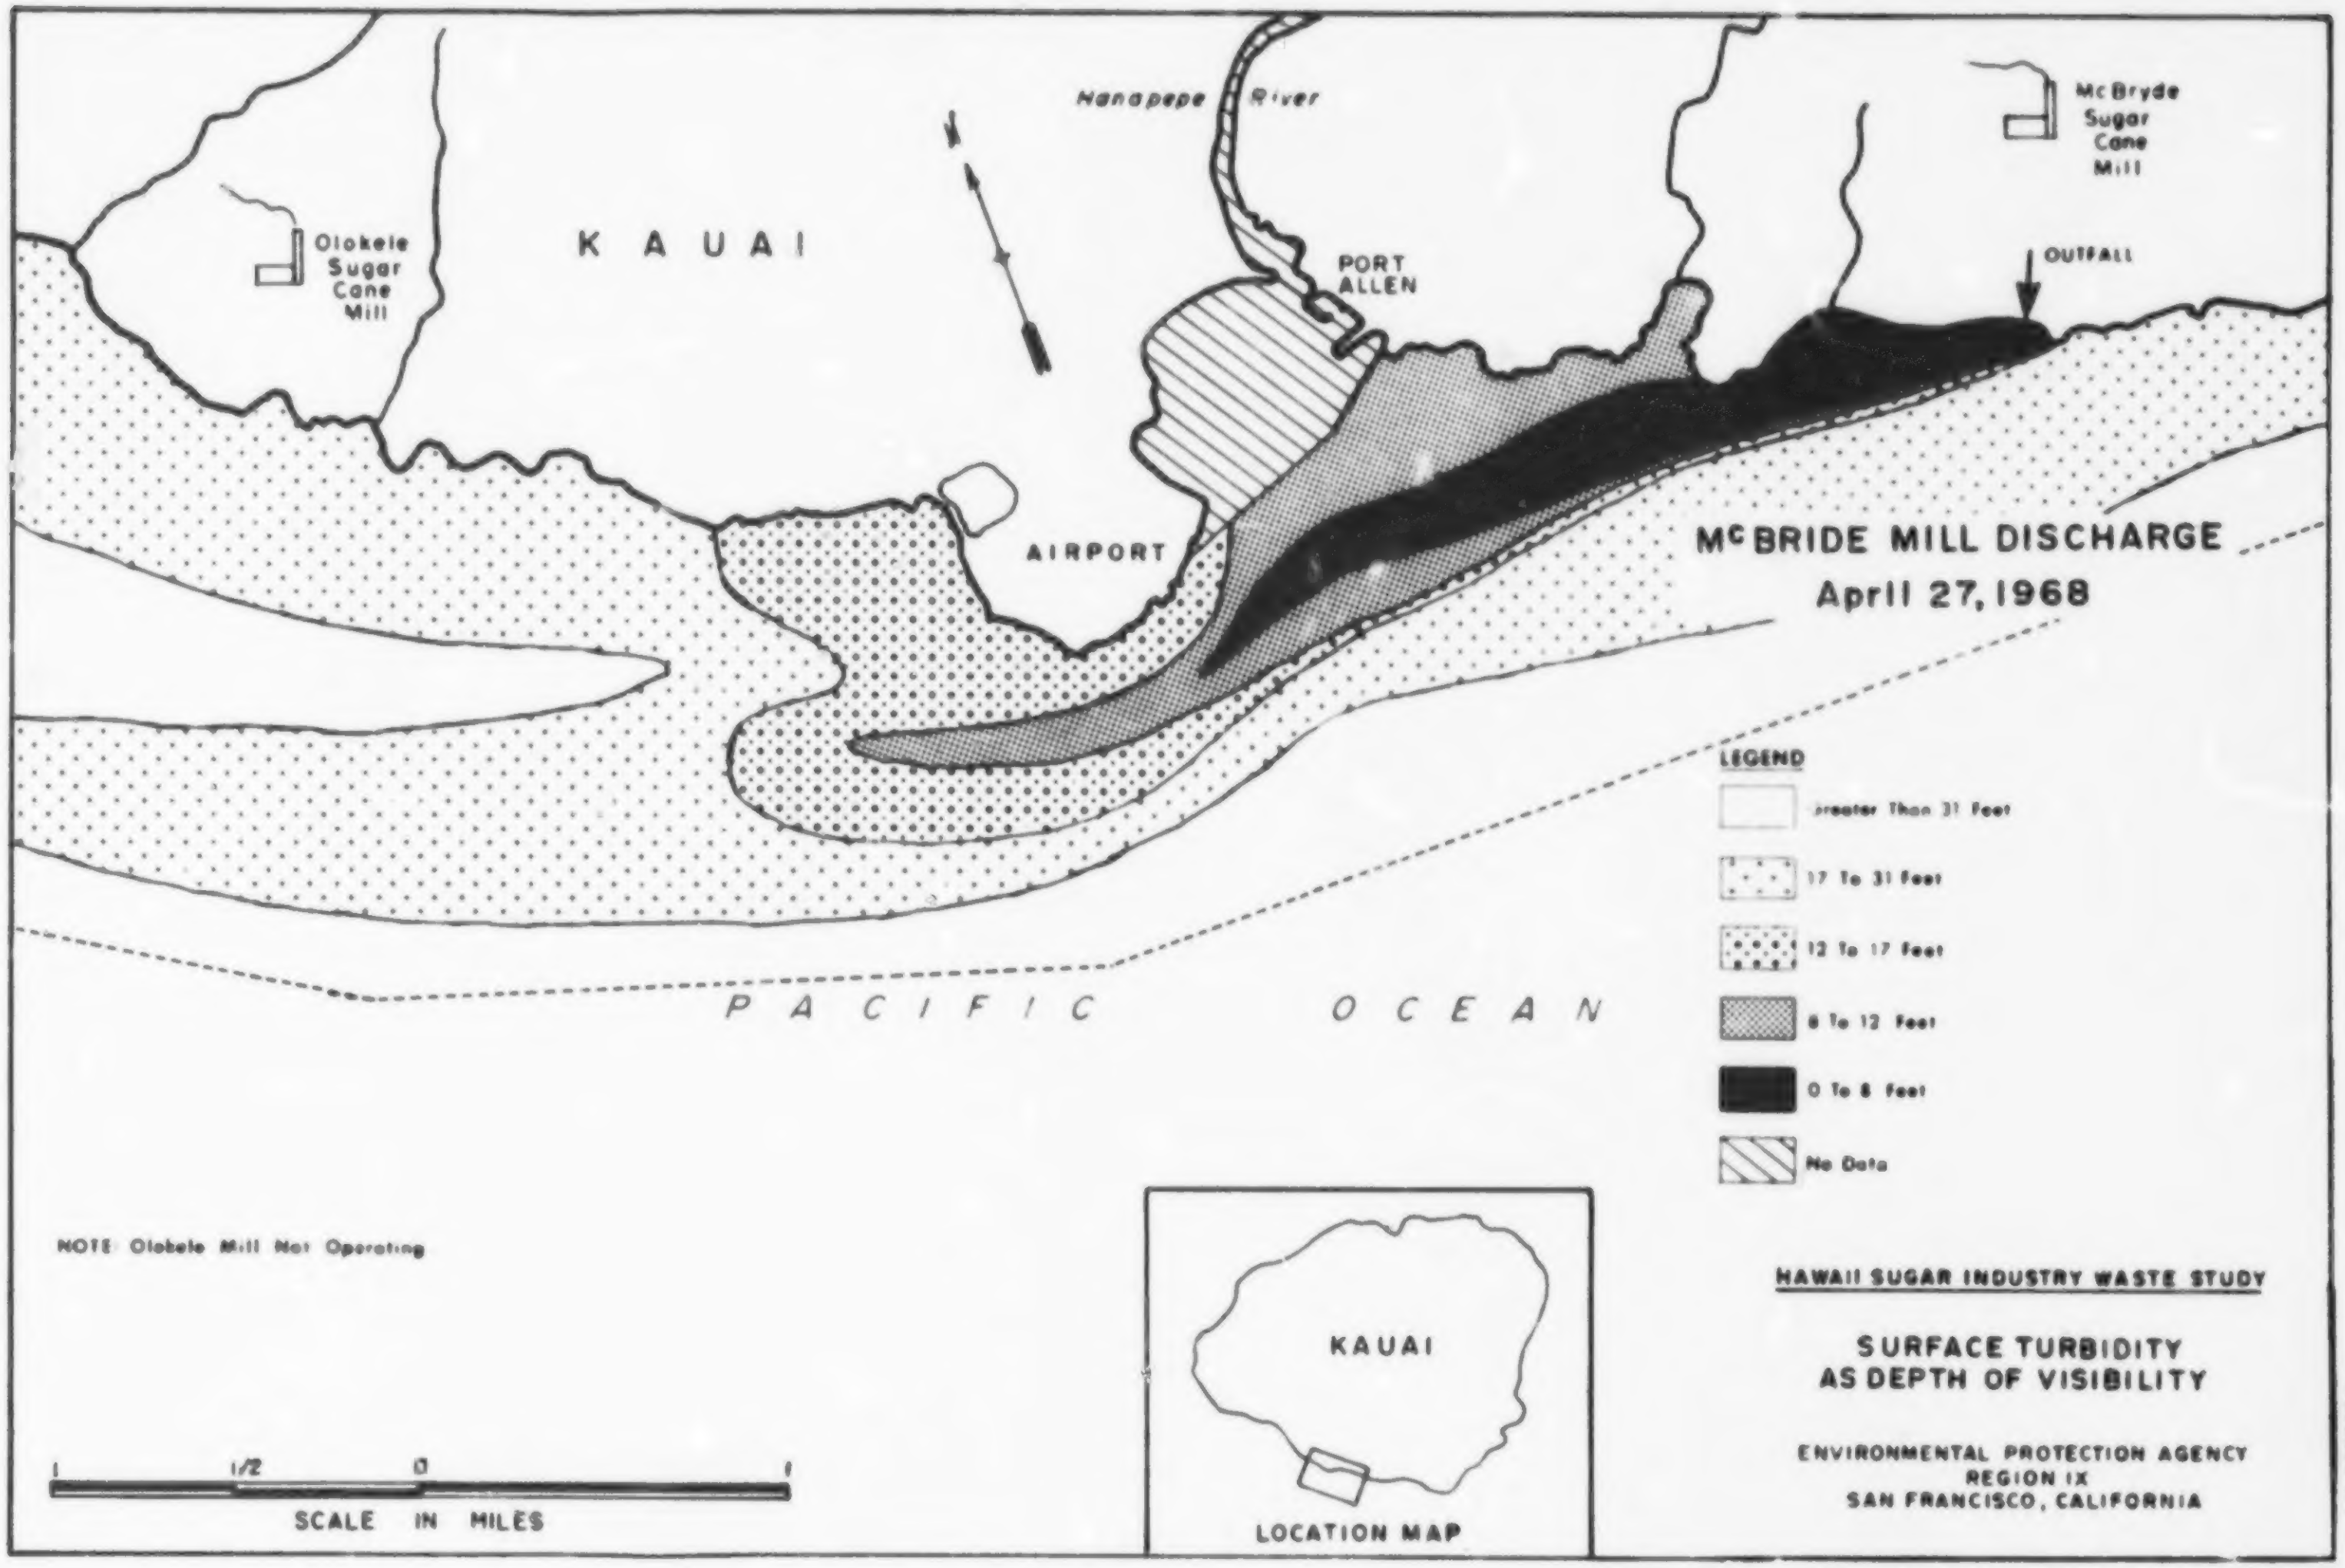
FIGURE 16

The mill discharge formed a bright reddish-brown streak, closely approximated on Figure 16 by the darkest zoning. This streak continued to flow for about two and a half miles from the actual discharge point before diffusion sufficiently dispersed it. Turbidity attributable to the outfall continued for at least another mile along the coastline.

McBRIDE MILL DISCHARGE
April 27, 1968

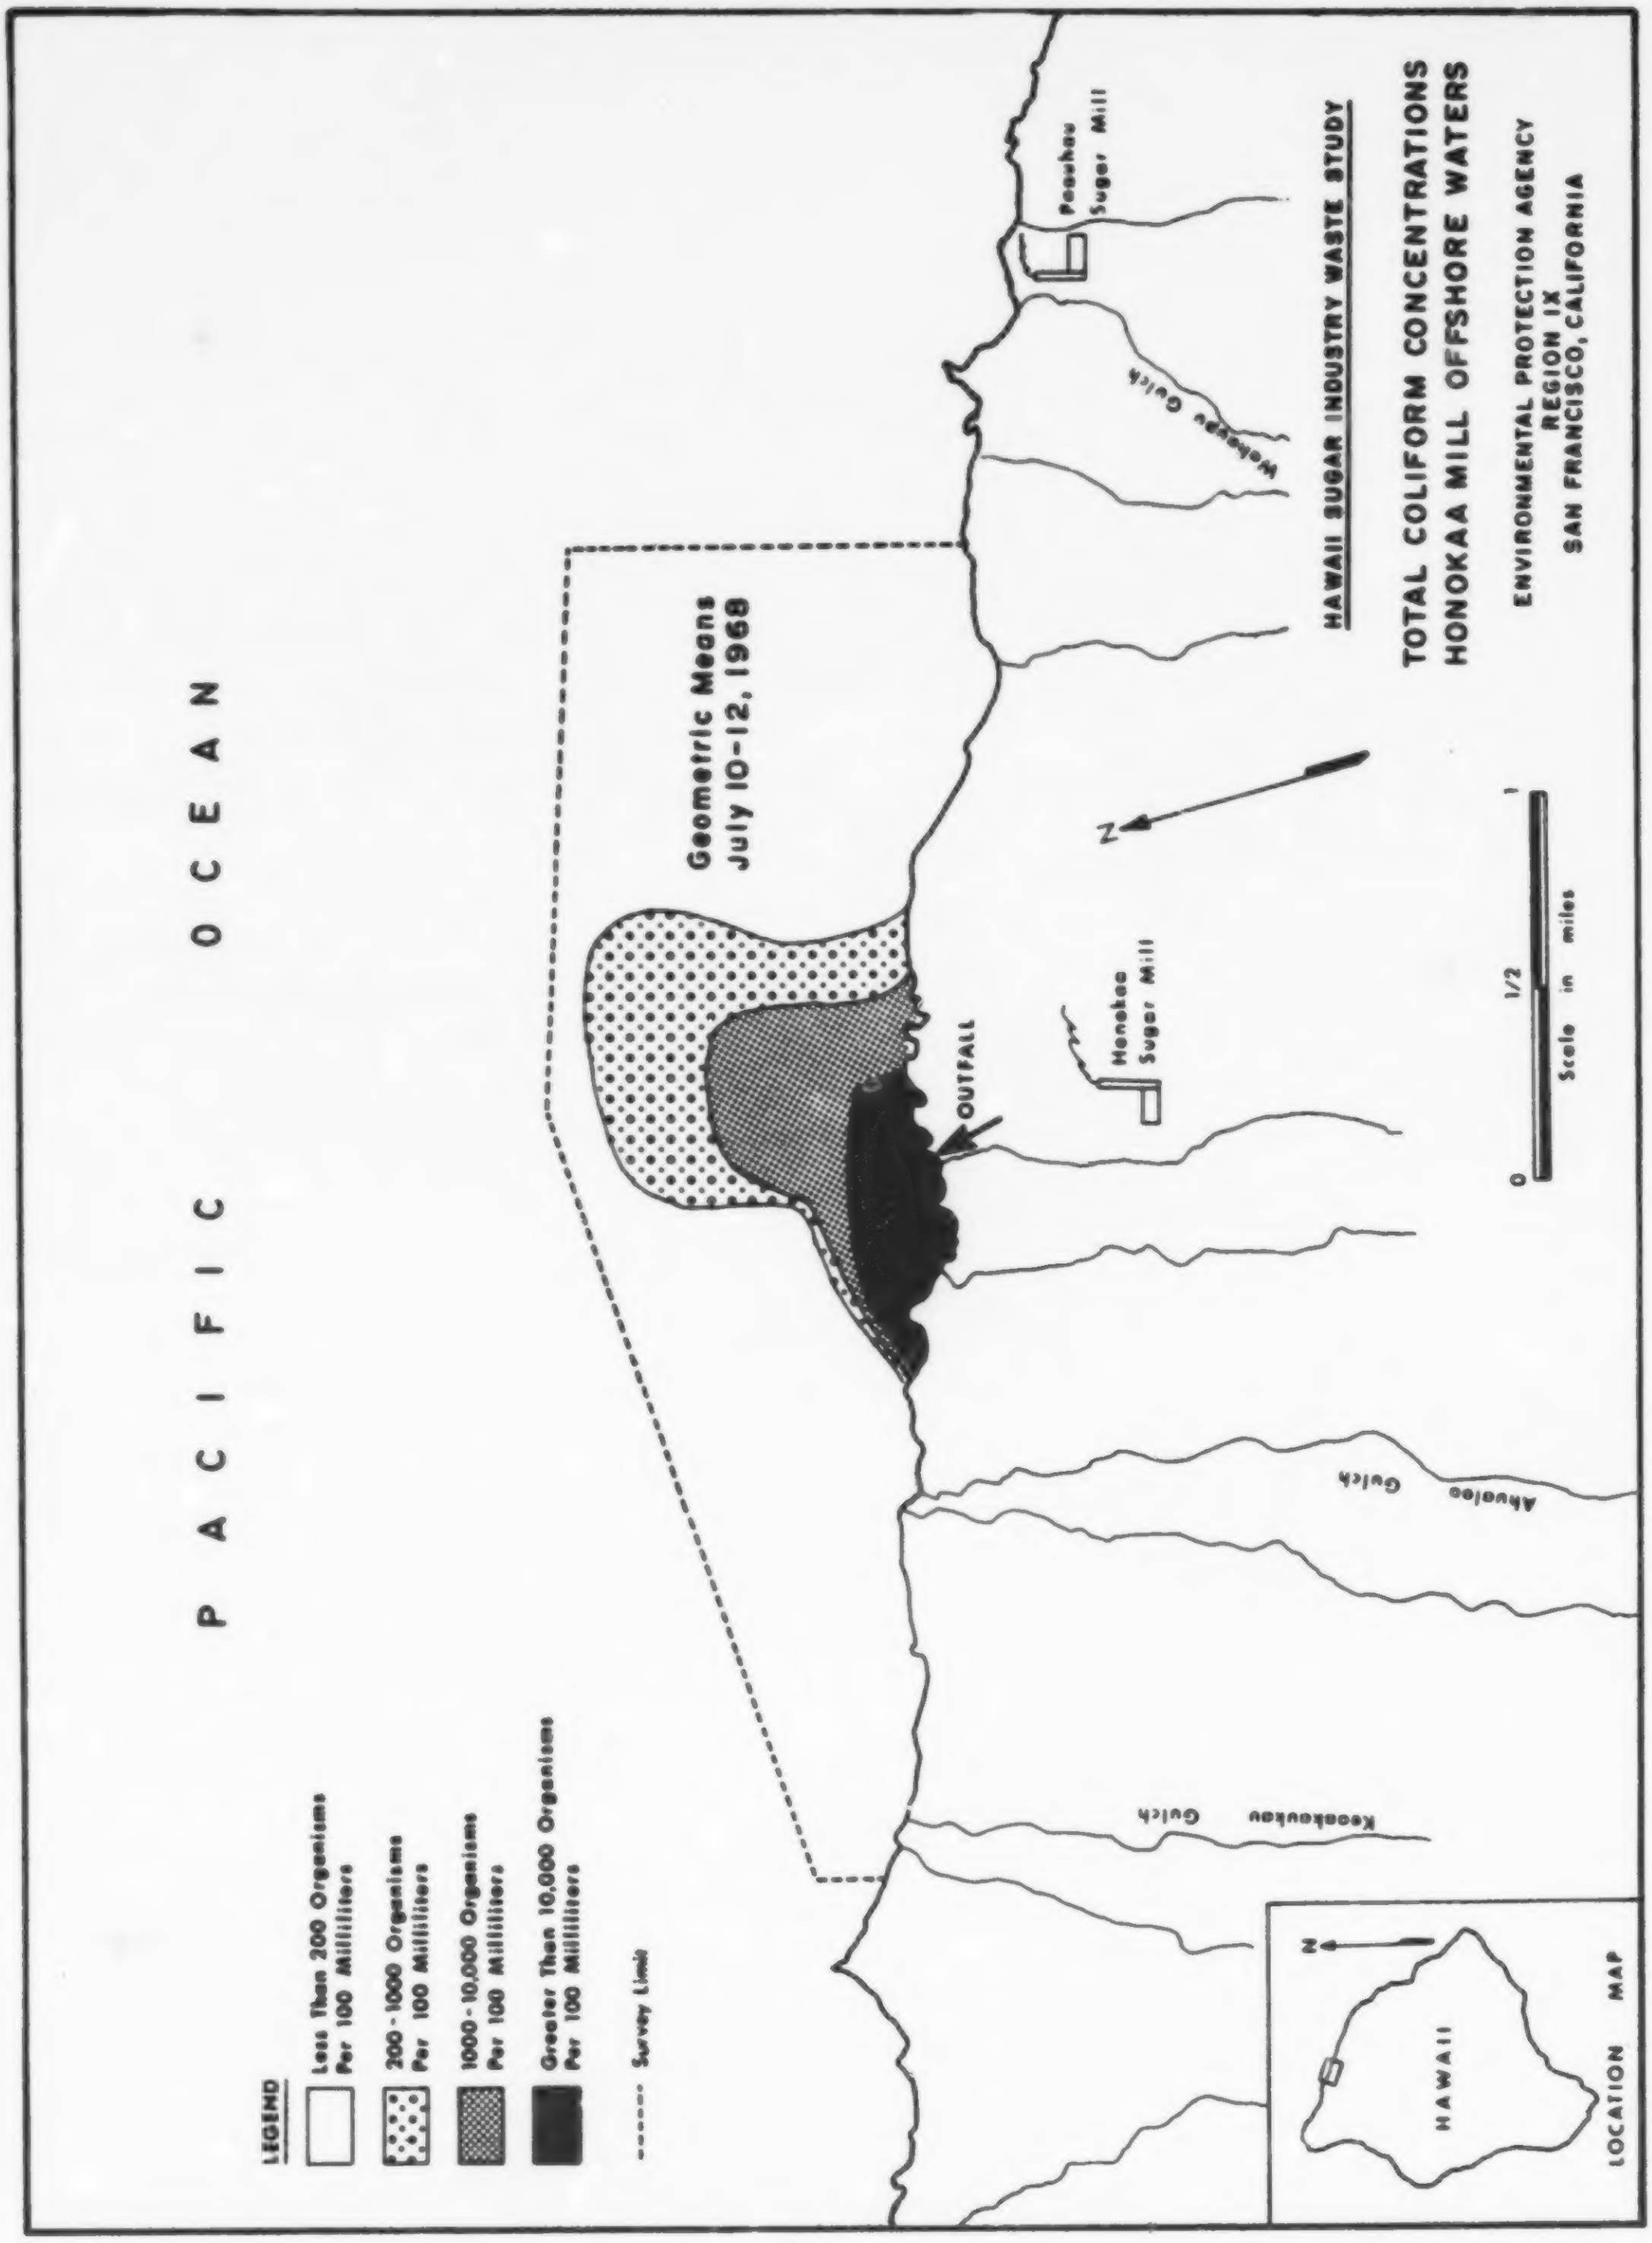
FIGURE 17

Honokaa Mill: Figure 17 shows the geometric mean values for total coliform concentrations during four sampling periods conducted on July 10-12. Field notes during the period indicated also that the area of discoloration followed patterns similar to those shown in Figure 17. The average densities exceeded 10,000/100 ml, for a surface area of about 90 acres surrounding the mill outfall. The numbers then diminished in a northeasterly direction to 200/100 ml (Figure 12) and reached a maximum distance of about one mile from the outfall.
